# Asbestos Management Report

## Meadow View Industrial Estate

Reference: PVES/MV/03.23

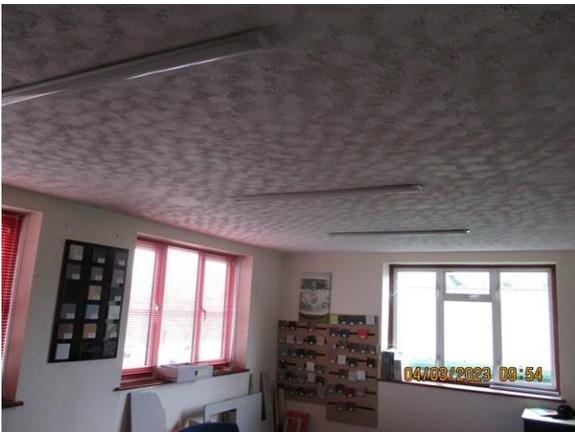
U12 S01 Ceiling Coating

S01 Ceiling Coating

> Unit 12 > 1 Mezzanine Floor > Showroom

Confirmed  
NADIS

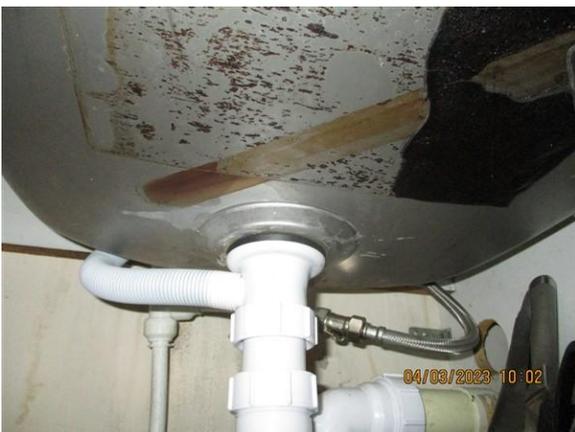
U12 S02 Sink Pad

S02 Sink Pad

> Unit 12 > 1 Mezzanine Floor > Kitchen

Confirmed  
NADIS

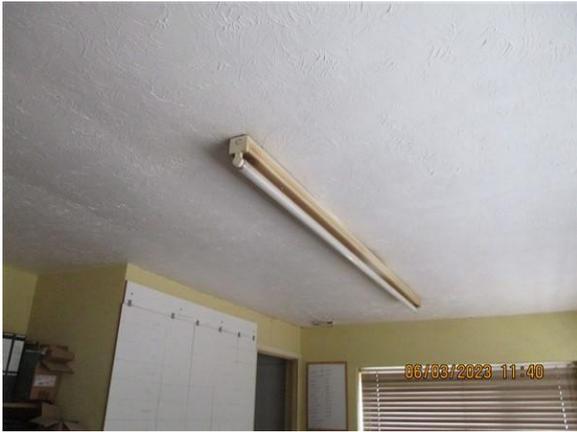
U2 S01 Ceiling Coating

S01 Ceiling Coating

> Unit 2 > 0 Ground Floor > Office

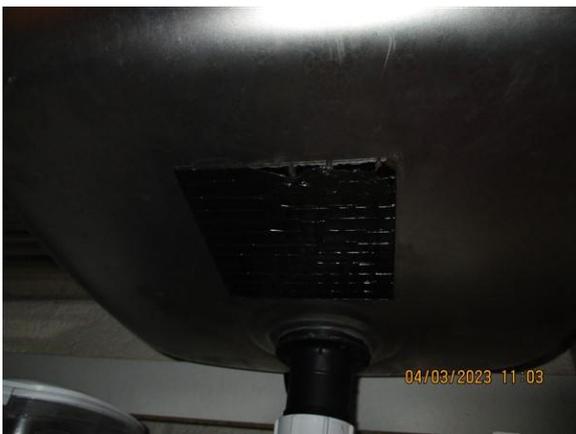
U4 S01 Sink Pad

S01 Sink Pad

> Unit 4 > 0 Ground Floor > Kitchen

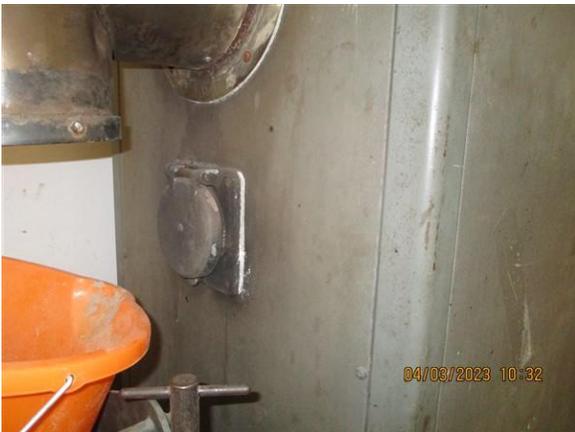
U8 S01 Gasket

- I Unit 8 - Sample S01 Flange Gasket to Heater. Found on the external side of the heater unit, we recommend the gasket be encapsulated with appropriate heat resistant material. Access to the heater was not possible as it was live at the time of our inspection.

S01 Gasket

> Unit 8 > 0 Ground Floor > Workshop

Confirmed

Chrysotile (White)

<u>Actions</u>	<u>Due By</u>	<u>Estimated Cost</u>	<u>Status</u>
Maintain and Update log of ACMs	16/03/2023		Active
Encapsulate	16/03/2023		Active
Monitor Condition	28/04/2023		Active

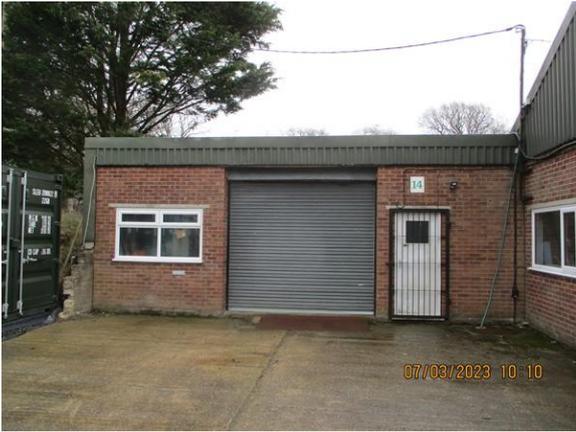
Denined Access

> Unit 14 > 0 Ground Floor > All Rooms
