# Asbestos Management Report

## Meadow View Industrial Estate

Reference: PVES/MV/03.23

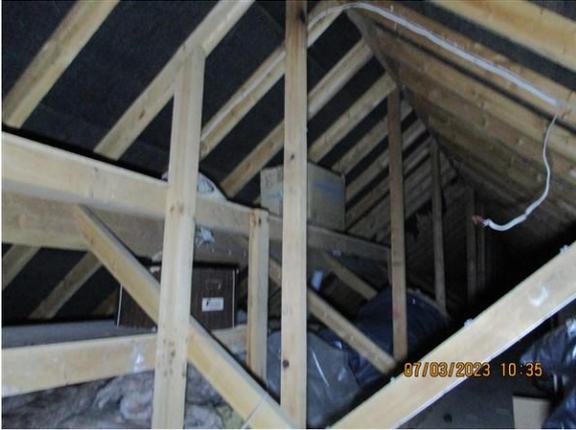
U1 Loft Space

No Asbestos Detected

> Unit 1 > 1 Roof Level > Loft Space

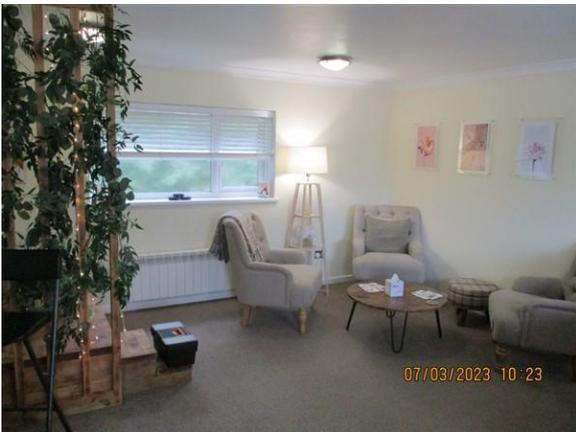
U1 Reception

No Asbestos Detected

> Unit 1 > 0 Ground Floor > All Rooms

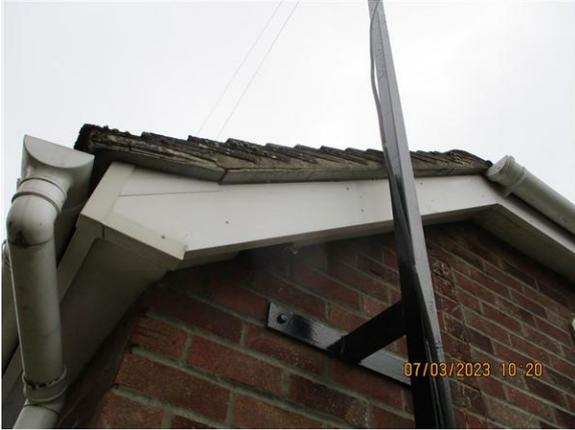
U1 S01 Cloaking

S01 Cloaking Strip

> Unit 1 > 1 Roof Level > External

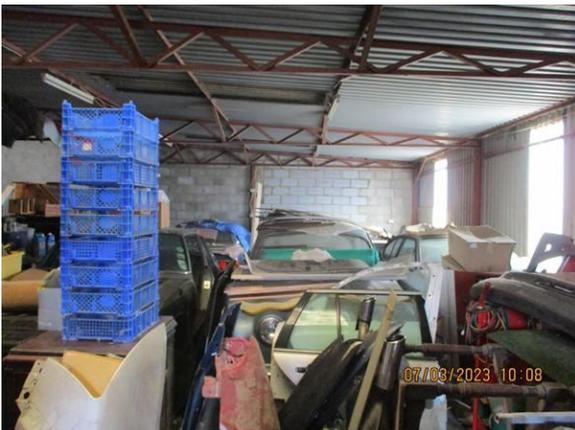
U10 Workshop

No Asbestos Detected

> Unit 10 > 0 Ground Floor > Workshop

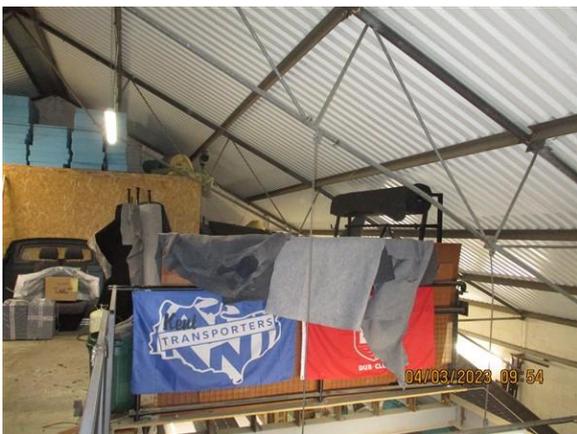
U12 Mezz

No Asbestos Detected

> Unit 12 > 1 Mezzanine Floor > Storeroom

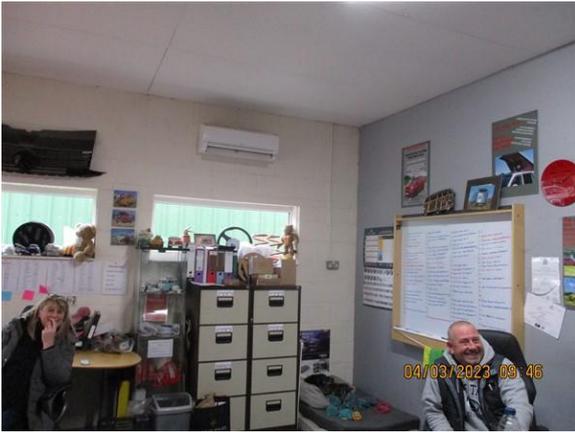
U12 Office

No Asbestos Detected

> Unit 12 > 0 Ground Floor > All Rooms

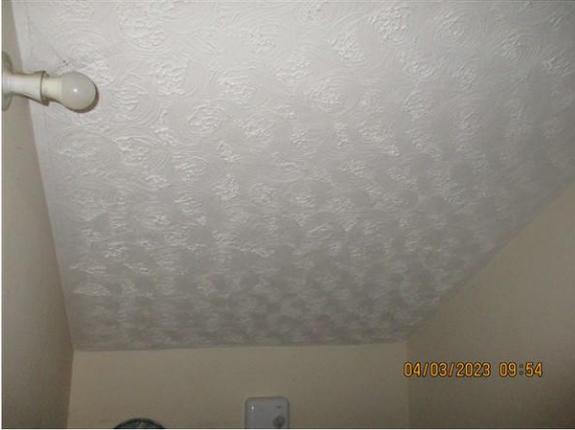
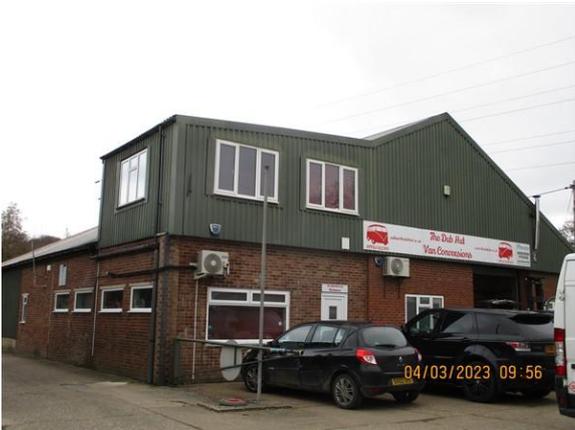
U12 SPST S01 Ceiling Coating

SPST S01 Ceiling Coating

> Unit 12 > 1 Mezzanine Floor > Kitchen

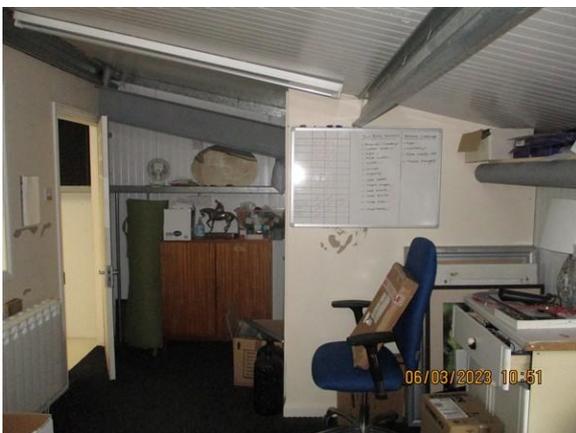
## U15 Offices

No Asbestos Detected

> Unit 15/16 > 1 Mezzanine Floor > Office

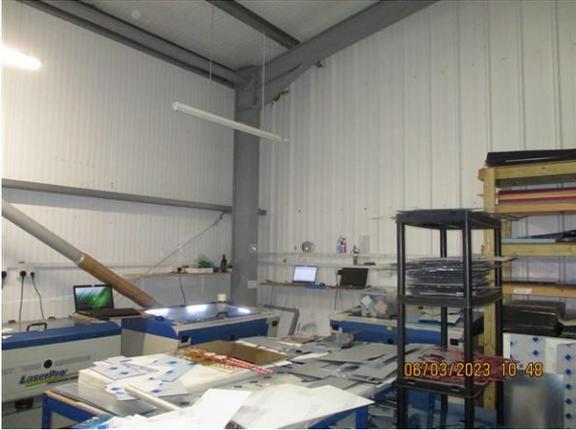
U15 Workshop

No Asbestos Detected

> Unit 15/16 > 0 Ground Floor > All Rooms

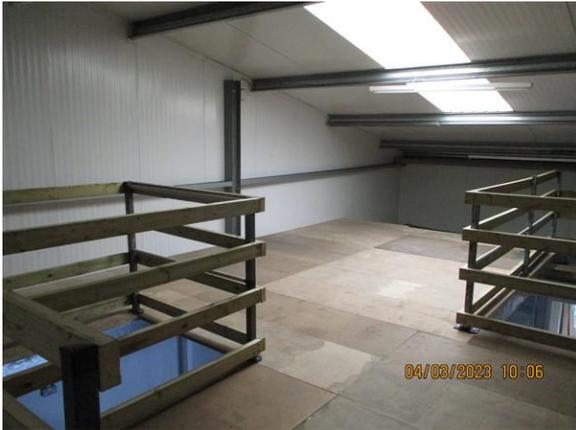
U17 Mezz

No Asbestos Detected

> Unit 17 > 1 Mezzanine Floor > Store Room

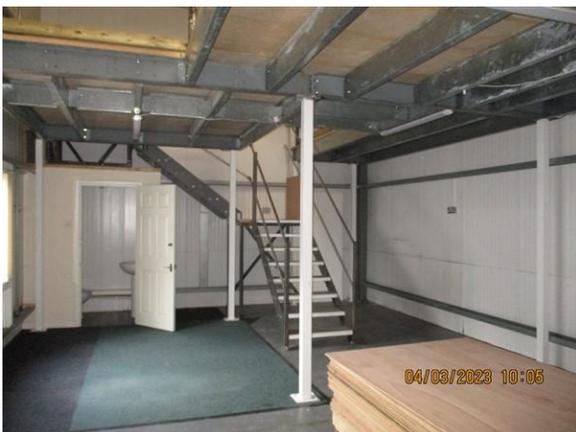
U17 Workshop

No Asbestos Detected

> Unit 17 > 0 Ground Floor > All Rooms

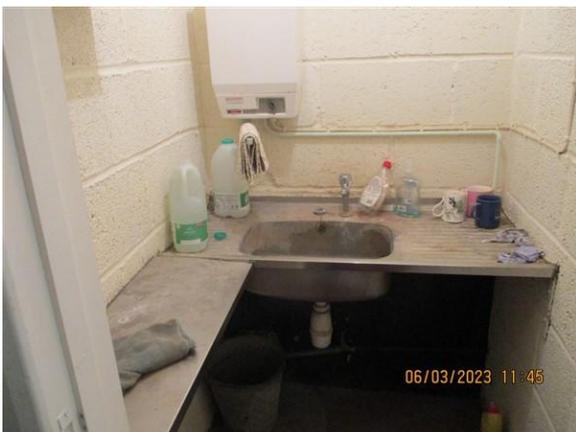
U2 Kitchen

No Asbestos Detected

> Unit 2 > 0 Ground Floor > Stores, Kitcehn & Cloakroom

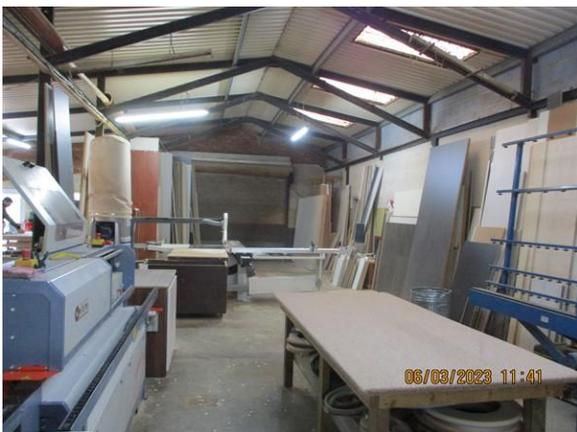
U2 Workshop

No Asbestos Detected

> Unit 2 > 0 Ground Floor > Workshop

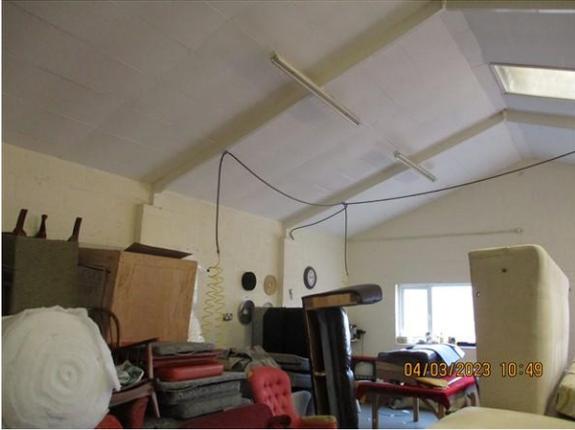
U4 Workshop

No Asbestos Detected

> Unit 4 > 0 Ground Floor > All Rooms

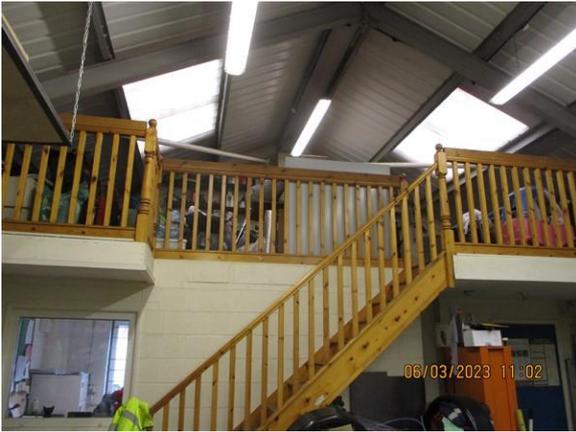
## U6 Mezz

No Asbestos Detected

> Unit 6 > 1 Mezzanine Floor > Storeroom

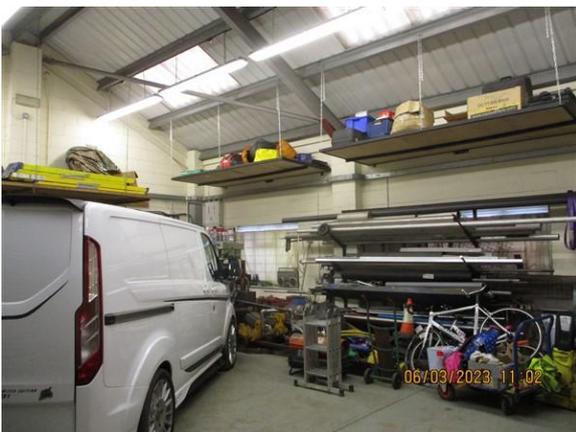
## U6 Workshop

No Asbestos Detected

> Unit 6 > 0 Ground Floor > All Rooms

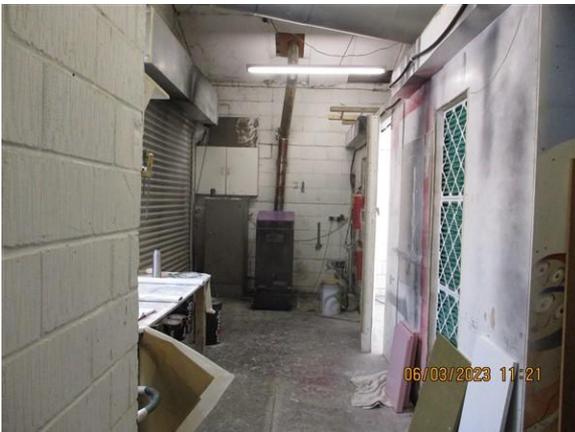
U7 Workshop

No Asbestos Detected

> Unit 7 > 0 Ground Floor > All Rooms

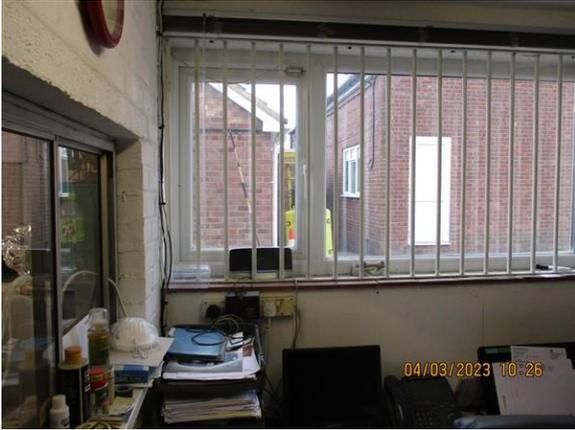
U8 Office

No Asbestos Detected

> Unit 8 > 0 Ground Floor > Office & Cloakroom

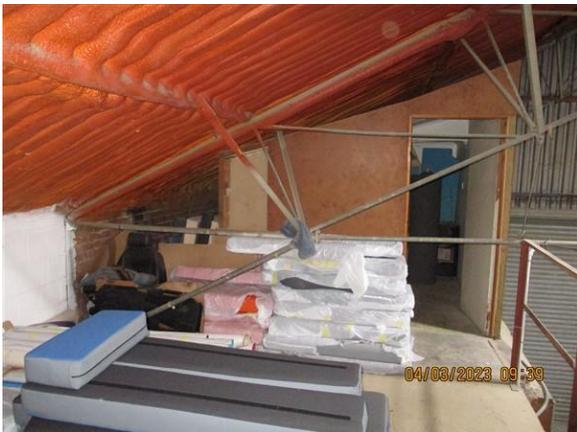
U9 Mezz

No Asbestos Detected

> Unit 9 > 1 Mezzanine Floor > Storeroom

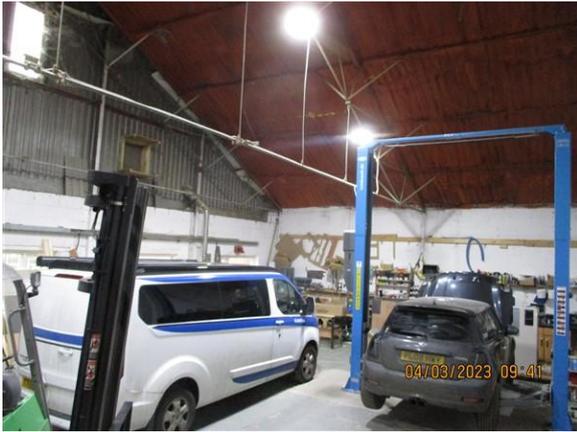
U9 Workshop

No Asbestos Detected

> Unit 9 > 0 Ground Floor > All Rooms

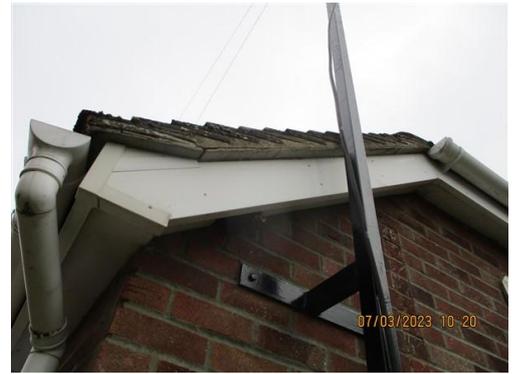
> Unit 1 > 1 Roof Level > External

## S01 Cloaking Strip

Inspection Date 06/03/2023  
Inspected by Paul Craddock  
Next Inspection Date  
Identification Confirmed  
Asbestos Type NADIS

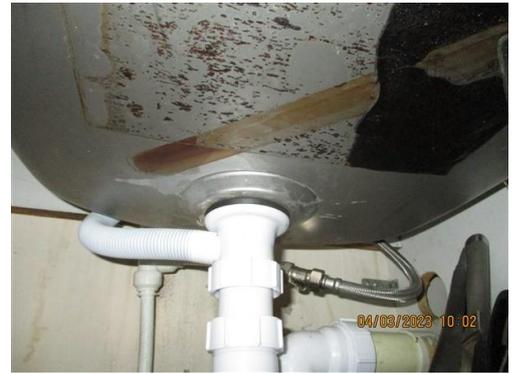
> Unit 12 > 1 Mezzanine Floor > Kitchen

## S02 Sink Pad

Inspection Date 06/03/2023  
Inspected by Paul Craddock  
Next Inspection Date  
Identification Confirmed  
Asbestos Type NADIS

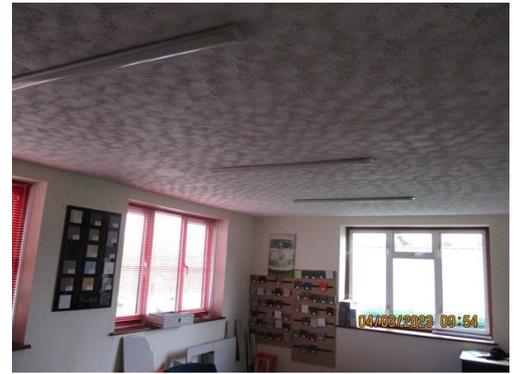
> Unit 12 > 1 Mezzanine Floor > Showroom

## S01 Ceiling Coating

Inspection Date 06/03/2023  
Inspected by Paul Craddock  
Next Inspection Date  
Identification Confirmed  
Asbestos Type NADIS

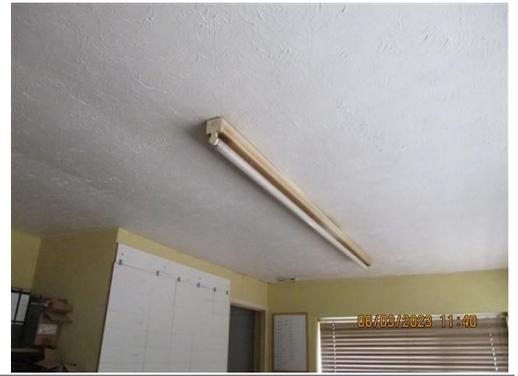
> Unit 2 > 0 Ground Floor > Office

## S01 Ceiling Coating

Inspection Date 06/03/2023  
Inspected by Paul Craddock  
Next Inspection Date  
Identification Confirmed  
Asbestos Type NADIS

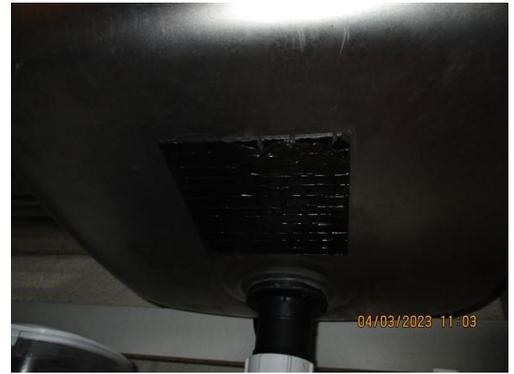
> Unit 4 > 0 Ground Floor > Kitchen

## S01 Sink Pad

Inspection Date 06/03/2023  
Inspected by Paul Craddock  
Next Inspection Date  
Identification Confirmed  
Asbestos Type NADIS

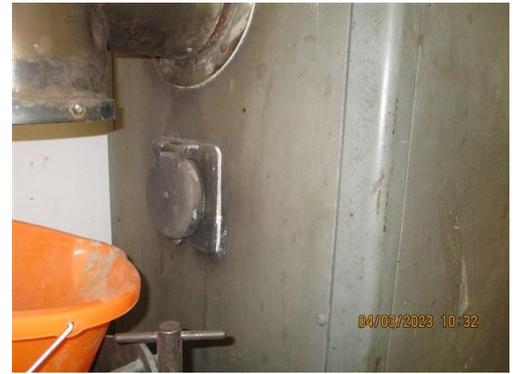
> Unit 8 > 0 Ground Floor > Workshop

- I Unit 8 - Sample S01 Flange Gasket to Heater. Found on the external side of the heater unit, we recommend the gasket be encapsulated with appropriate heat resistant material. Access to the heater was not possible as it was live at the time of our inspection.

## S01 Gasket

<u>Inspection Date</u>	06/03/2023
<u>Inspected by</u>	Paul Craddock
<u>Next Inspection Date</u>	05/09/2023
<u>Identification</u>	Confirmed
<u>Asbestos Type</u>	Chrysotile (White)

<u>Asbestos Type</u> 1	Chrysotile (White)
<u>Product Type</u> 2	Asbestos Insulating Board, mill boards, other low density insulation boards, asbestos textiles, gaskets, ropes and woven textiles, asbestos paper and felt.
<u>Extent of Damage / Deterioration</u> 1	Low damage. A few scratches or surface marks, broken edges on boards, tiles etc.
<u>Surface Treatment</u> 2	Unsealed asbestos insulating board, or encapsulated lagging and sprays.

<u>Actions</u>	<u>Due By</u>	<u>Estimated Cost</u>	<u>Status</u>
Maintain and Update log of ACMs	16/03/2023		Active
Encapsulate	16/03/2023		Active
Monitor Condition	28/04/2023		Active
